CASE STUDY KARABÜK UNIVERSITY

DECEMBER 2023

EEPB/DB/MoEU/QCBS-SUBPR-01

ABOUT THE PROJECT – KABEV

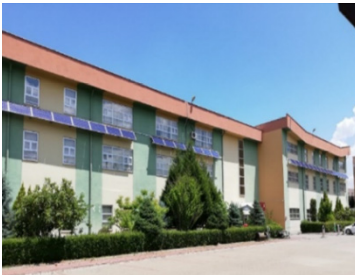
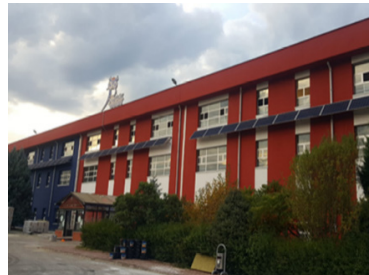
Picture 1. Karabük University (Before vs After)

Karabük University is a university with four educational blocks (Rectorate building, Engineering Faculty, Faculty of Administrative Sciences, Foreign Languages Institute) and an energy centre block. The buildings are about 14 years old. They had major technical and comfort problems such as insufficient heating due to often poor operation of heating water circulation loop, no control over HVAC system due to lack of a HVAC automation system, old and inefficient lighting system and high energy bills.

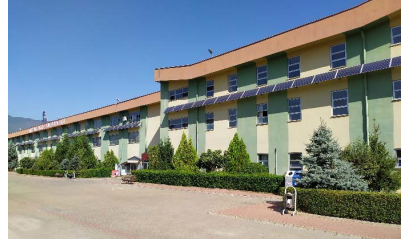
Foreign Languages Institute building was not insulated, had double pane windows in main building with old aluminum frames and therefore was cold in the winter. By installing 6 cm rock wool insulation on the façade of the building, it is now able to maintain a better indoor temperature as the heat losses are reduced. At the same time, the façade insulation and improved exterior image of the building, and it now appears as a new building from the outside.

Picture 2. Building Envelope (Before)

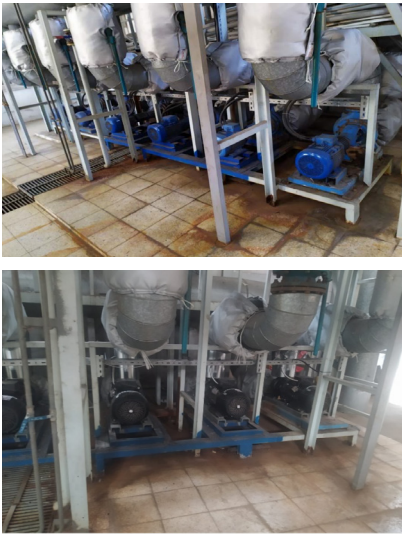
Heating system comprised of 5 pcs of floor mounted natural gas heating boilers (2 pcs of 2.000.000 kCal/h and 3 pcs of 2.500.000 kCal/h) in the energy center. Constant speed low efficiency heating water circulation pumps. Heating water circulation loop defects including use of wrong pipe diameters, pressure losses, pumps with bigger capacity than needed, wrong use of 3-way valves, etc.) causing too much interruption in heating system. Heating water circulation loop (piping, valves, heat exchangers, etc.) have been

Mechanical installation and plumbing instruments including piping, valves, etc. had no insulation. The piping and instrumentation in the boiler room have been replaced with new systems having proper insulation based on local plumbing insulation standard.

*Picture 4. Mechanical Installation and Pumps
(Before vs After)*

replaced with brand new and optimized capacity components. Various types of heat pump options were also considered but, their payback period came out to be longer than KABEV project requirements. (Annual operation hour of the building for heating was around 600 hours which lead to respectively longer payback period of a heat pump investment.)

Now, the boilers with capacity modulation and hot water supply temperature reset capability provide as much heating energy as demanded by the buildings leading to much less heating energy consumption.

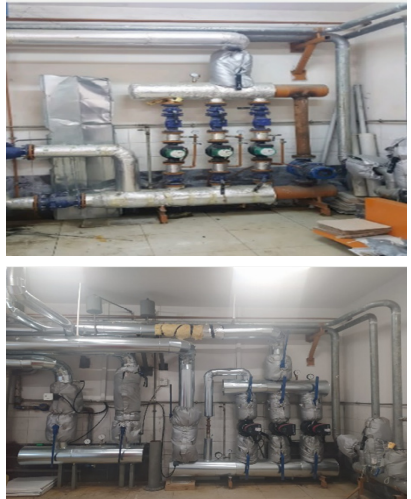
Constant speed heating water circulation pumps operate all the time and leading to excess energy consumption and low thermal comfort. Old and constant speed heating water circulation pumps have been replaced with brand new variable speed circulation pumps. Now, all the heating energy is distributed by more efficient circulation pumps avoiding overheating and excess heating energy consumption. Circulation pumps now adjust their speed and operate only as much as the heating demand leading to savings both in heating and pump energy.

*Picture 6. Circulation Pumps Replacement
(Before vs After)*

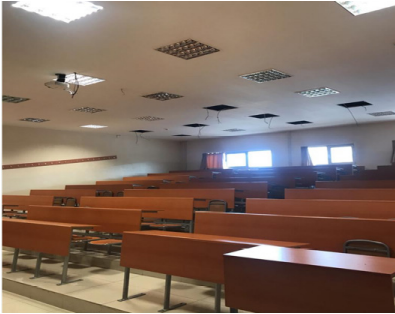
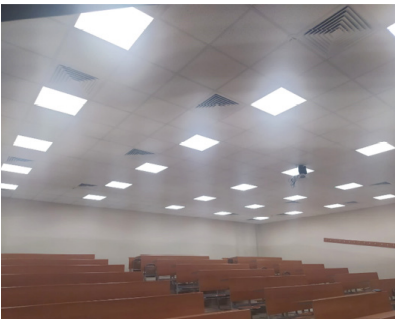
There were lighting fixtures of various types and powers within the university campus buildings. Luminaires generally used were surface mounted T8 fluorescents with magnetic ballast for interior lighting. All inefficient luminaires have been replaced with more efficient LEDs.

Picture 7. Old Fluorescent T8 bulbs vs LED lighting

In order to make an overall evaluation of lighting system, lighting fixtures inventory was prepared first. Types of lighting fixtures, their power, location, daily and annual operation hours were identified. Energy saving calculations were done based on these parameters. As a result, over 5.500 pieces of lighting bulbs have been replaced with LED type bulbs.

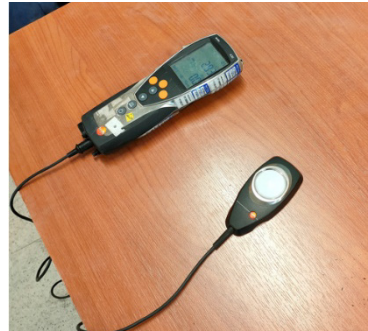
Illuminances and lighting levels were measured during energy audit and after the renovation works were implemented. Site survey interviews with building staff and visual inspection of a lighting expert during measurement and verification process confirmed that there was no issue in lighting levels with the new lighting fixtures. Luminous flux of the proposed LED luminaires have been better than the existing T8 luminaires. Hence, better lighting quality has been experienced after lighting retrofit works.

Picture 8. Illuminance level measurement

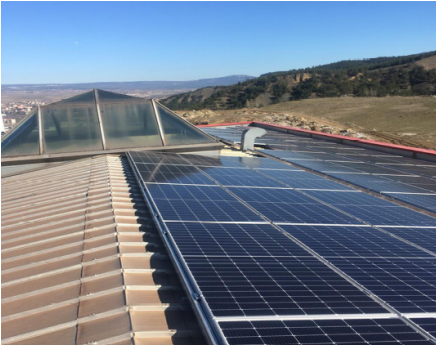
There was no renewable energy system within the educational facility before. After reducing the energy demand and consumption to the minimum level, on-site renewable energy measure has been adopted in order to further reduce carbon footprint of the facility. Solar photovoltaic system with a 100 kW_e rated power has been applied at rooftops based on the effective roof area and transformer capacity of the facility.

Picture 9. Rooftop solar photovoltaics (PV)

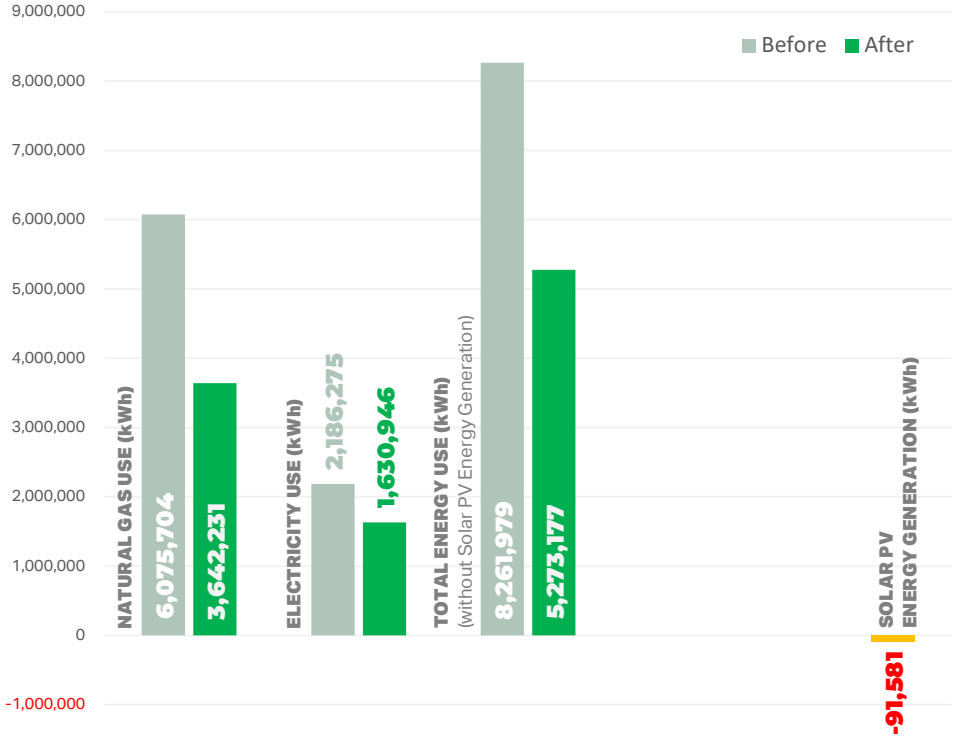
Comparison of natural gas and electricity energy before and after EEMs are

implemented are provided below along with onsite renewable energy.

Graph 2. Energy Use Breakdown and Energy Generation Comparison (Before vs After)
