JULY 2023 EEPB/DB/MoEU/QCBS-SUBPR-01

REPUBLIC OF TURKEY MINISTRY OF ENVIRONMENT, URBANIZATION AND CLIMATE CHANGE

# **ABOUT THE PROJECT – KABEV**

# **BURSA KIZ LİSESİ** 2 School Blocks + 1 Bursa, Türkiye **Public School Dormitory Block** Enerav 10.285 m<sup>2</sup> Performance **High School and Contract (EPC)** Dormitory THE BURG THE THERNE 10.000 f Т

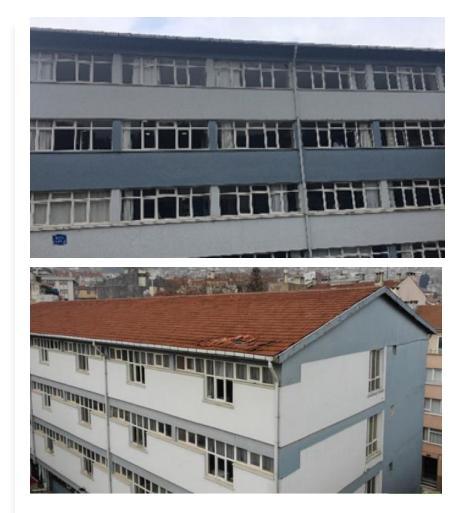
Picture 1. Bursa Kız Lisesi – A Block Pictures – old at the left, new at the right side

Bursa Kız Lisesi is a high school with two educational blocks and one dormitory block. The buildings are over 40 years old and had an old appearence due to lack of sufficient maintenance. They had major technical and comfort problems such as insufficient heating due to lack of façade insulation and often malfunctioning boilers, excessive infiltration through old single pane windows.

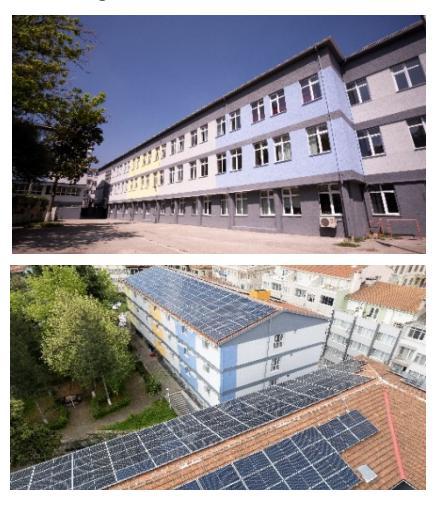
Picture 2. Building façades and roofs – Before (Left) vs After (Right)

Buildings were not insulated and had single pane windows and therefore was cold in the winter and hot in the summer. By installing 10 cm rock wool insulation on the façade and attic of the building and replacement of the windows to triple pane windows with highly insulating frames, it is now able to maintain a better indoor temperature as the heat losses are reduced in the winter and the heat gain is reduced in the summer. At the same time, the façade insulation and brand new windows improved the exterior of the building, and it now appears as a new building from the outside.

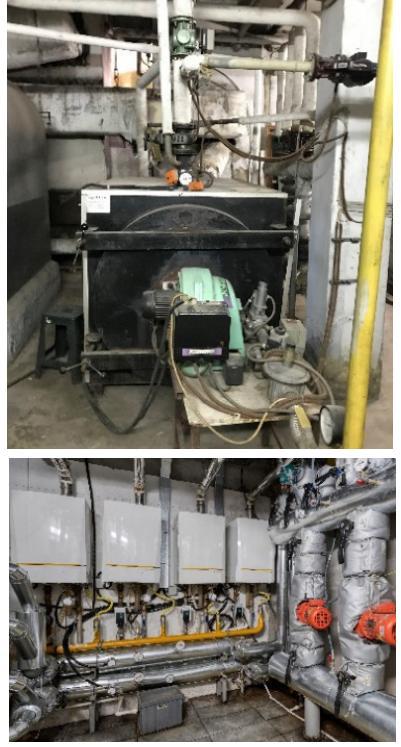
Picture 3. Boiler Room - Before vs After

Heating system comprised of 700 kW floor mounted natural gas heating boiler, radiators with old valves and constant speed low efficiency circulation pumps. Boilers had frequent faults causing too much interruption in heating system. Additionally, thermal efficiency of the boilers were found out to be low when flue gas measurements were carried out. Boilers have been replaced with brand new and efficient 4 x 90 kW wall mounted cascade natural gas condensing boiler. Now, the boilers with higher thermal efficiencv and capacity modulation provides as much heating energy as demanded by the buildings leading to much less heating energy consumption.

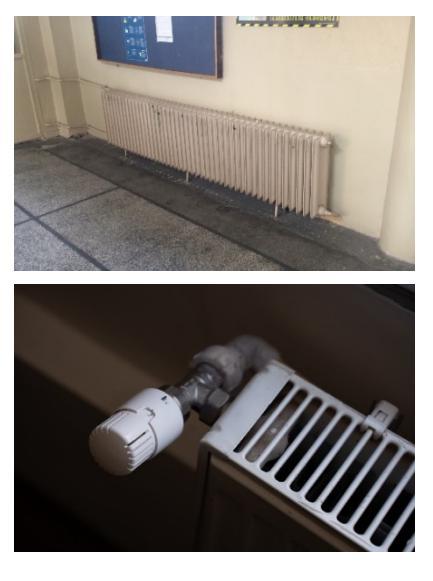
Picture 4. Radiator and Thermostatic Valves – Before vs After

The radiators were old and rusty inside along with old fashioned valves causing constant speed heating water circulation pumps operate all the time and leading to excess energy consumption and low thermal comfort. Radiators have been replaced with brand new panel radiators. Old valves have been replaced with thermostatic valves in radiators. Old and constant speed heating water circulation pumps have been replaced with brand new variable speed circulation pumps. Now, all the spaces are heated by more efficient radiators controlled by thermostatic valves bringing the rooms to ideal heating temperature and avoiding overheating and excess heating energy consumption. Circulation pumps now adjust their speed and operate only as much as the heating demand leading to savings both in heating and pump energy.

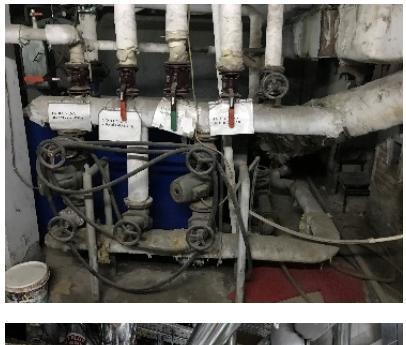
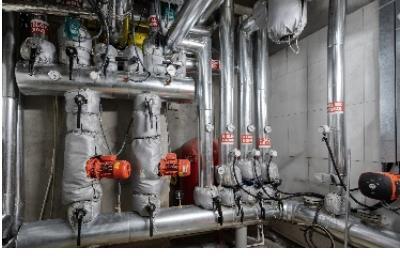
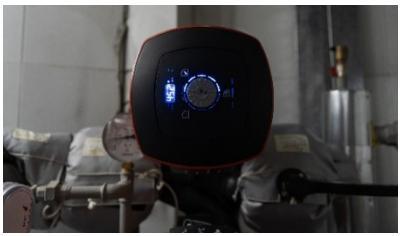
Picture 5. Boiler Room Pumps- Before vs After

Mechanical installation and plumbing instruments including piping, valves, etc. had no insulation. The piping and instrumentation in the boiler room have been replaced with new systems having proper insulation based on local plumbing insulation standard.

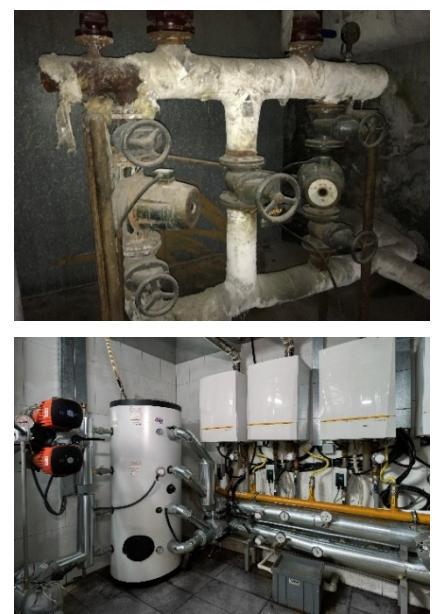
Picture 6. Boiler Room (Domestic Hot Water Tank) – Before vs After

Domestic hot water was provided by an old 175 kW floor mounted natural gas heating boiler and 2 pcs of old 500 litre hot water tanks. It's now provided by central cascade boiler system with 1.000 litre hot water tank. The central boiler system has higher efficiency compared to old boiler system leading to energy savings in domestic hot water heating.

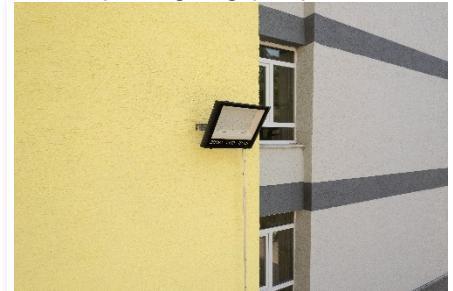
Picture 7. LED exterior lighting bulb

Old exterior lighting bulbs which are metal halide and sodium vapor type have been replaced with LED bulbs providing higher efficiency and lighting quality.

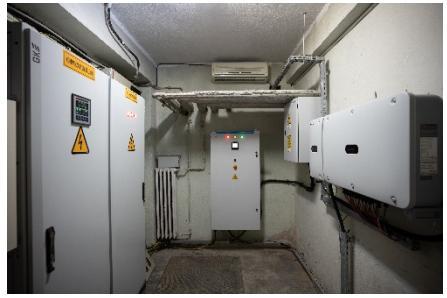
Picture 8. Replacement of compensation, main distribution control panels

Very old main distribution control panel was replaced with brand new main distribution control panel with enhanced electrical safety systems. Poorly working old compensation system experiencing penalty fees due to exceeding the reactive power limits of the electricity grid was replaced with brand new compensation system with higher capacity due to additionally installed frequency inverters, LED bulbs, etc.

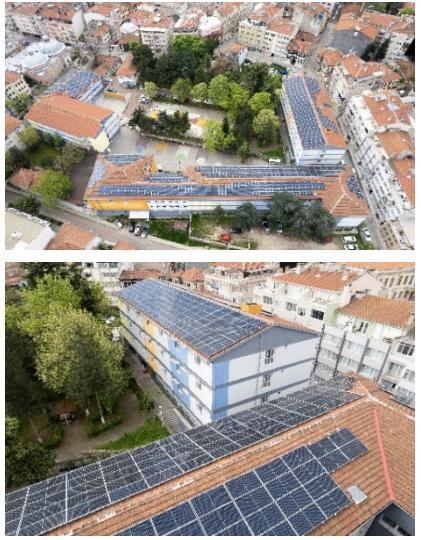
Picture 9. Rooftop solar photovoltaics (PV)

After reducing the energy demand and consumption to the minimum level. remaining energy was targeted to be generated on site by a rooftop solar photovoltaic system. Based on the transformer capacity of the buildings, solar photovoltaic system has been installed. Solar photovoltaic svstem's annual electricity generation is more than the buildinas' electricity consumption annually. This leads to exporting excess amount of electricity back to the grid to other educational facilities in the area especially in summer months when school's electricity consumption is low because it's closed and solar energy generation is at its peak due to respectively higher summer solar radiation level.

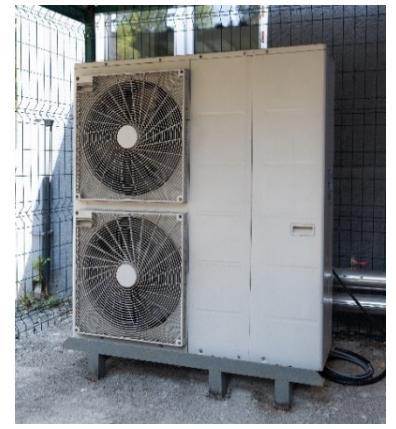
Picture 10. Heat pump application supported by solar PV system

Since the electricity consumption would be fully sourced from the solar photovoltaic system, it was considered to adopt a heat pump application to both support heating system and domestic hot water system.

It would decrease the fossil fuel use in natural gas boilers leading to mitigation of green house gas emissions originating from heating end use and its electricity consumption would be both free and zero emission because its electricity would be produced by onsite rooftop solar photovoltaic panels. As a result, 16 kW air sourced heat pump has been adopted into newly replaced heating system as an complimentary capacity during transition seasons and its power is generated by rooftop PV system.

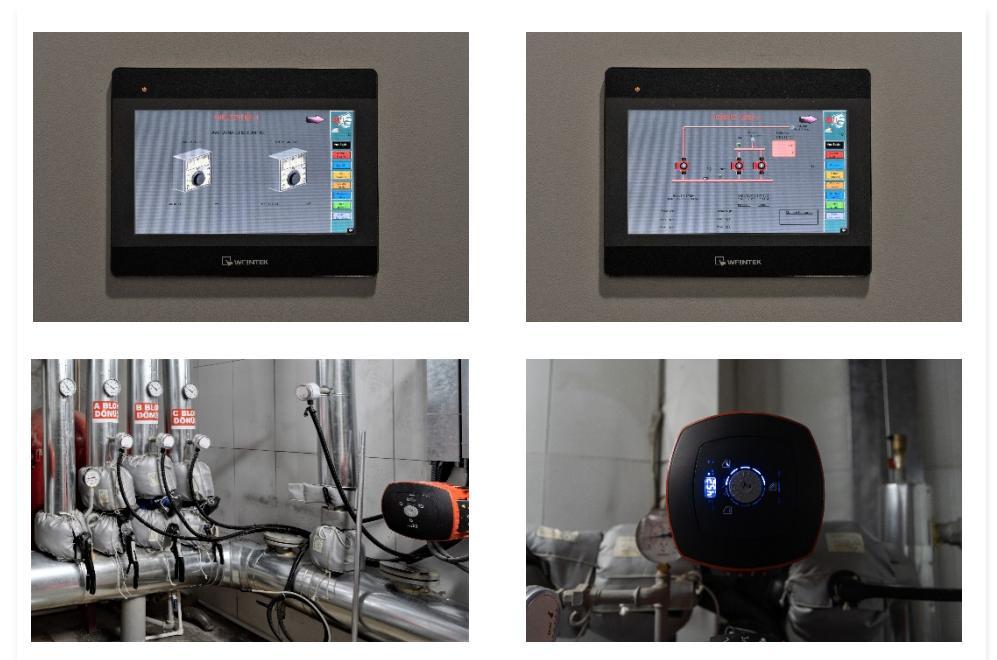
Picture 11. Heating automation system and associated equipment, sensors and valves

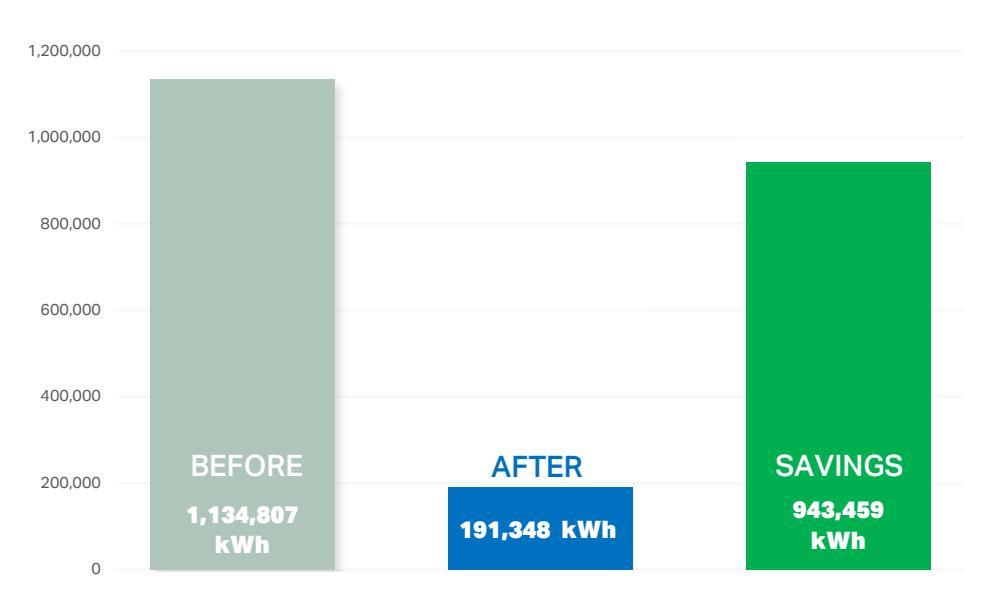
#### Net Energy Use and Total Savings [kWh]

Graph 1. Net Energy Use Comparison (Before vs After) and Total Savings

Baseline energy consumption of the building was 1.134.807 kWh/year even with insufficient heating. The energy use is reduced to 474.056 kWh/year corresponding to 58.2% savings without rooftop solar energy generation. When rooftop solar energy generation is included into the overall energy use calculations, 943.459 kWh/year energy is saved (corresponding to 83.1% savings) compared to 1.159.420 kWh/year ± 226.675 kWh/year<sup>2</sup> expected energy savings, meeting the expected level of savings.

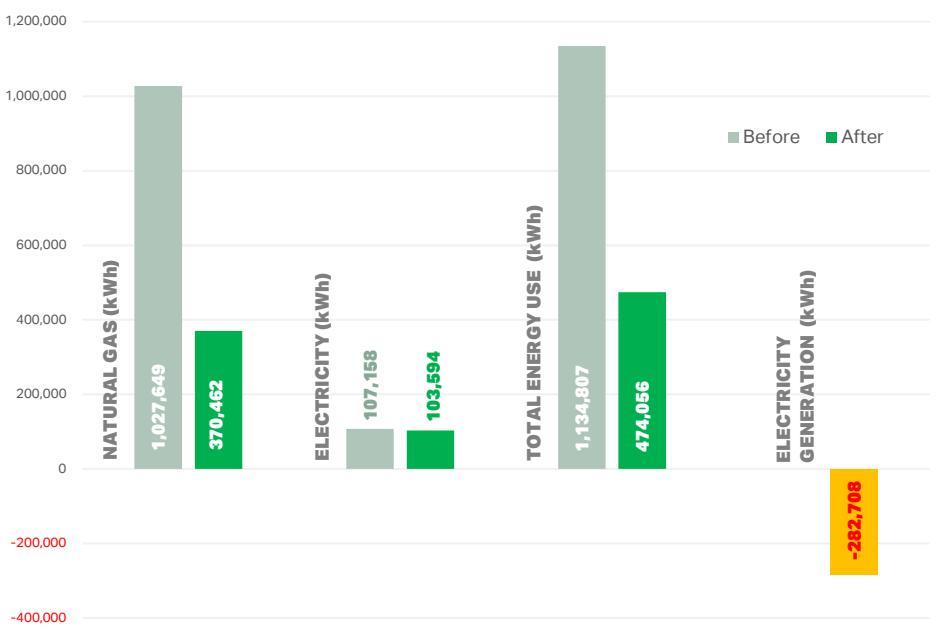
#### Energy Use Breakdown and Energy Generation [kWh]

Graph 2. Energy Use Breakdown and Energy Generation Comparison (Before vs After)

Comparison of natural gas and electricity energy before and after EEMs are implemented are provided below along with onsite renewable energy generation. Part of the generated energy is for self consumption of the school buildings. Excess part of the generated energy are exported the educational facilities nearby by sending back to the grid.

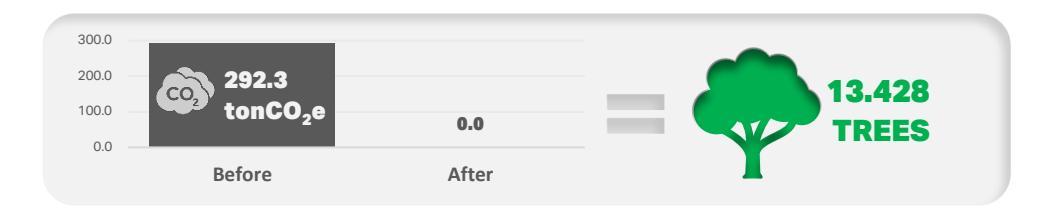
Graph 3. Green House Gas Emissions Comparison and Corresponding No of Trees

Green house gas emissions before and after EEMs are implemented are represented in below graph. Due to very high amount of energy savings and on-site renewable energy generation, overall green house gas emissions are reduced to net zero carbon level which would be a good example for other educational facilities and public buildings in terms of reaching to net zero carbon target in the future.

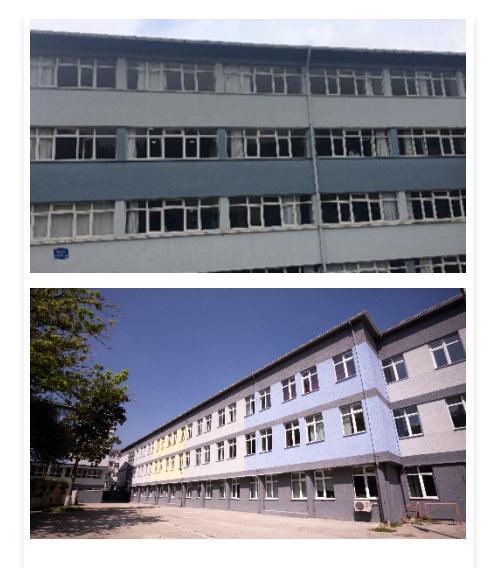
Picture 12. Building Facade – Before vs After

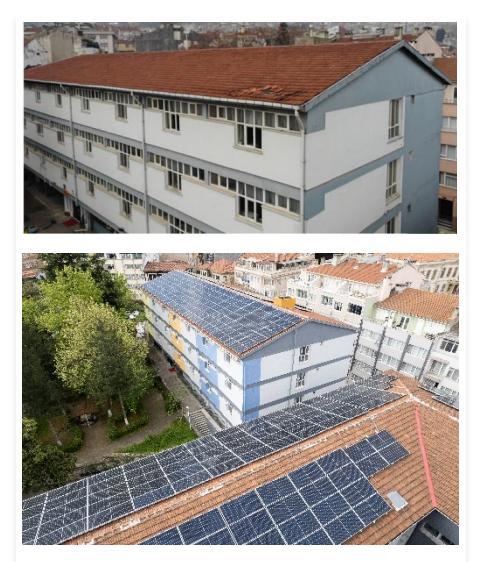
Picture 13. Building roofs - Before vs After

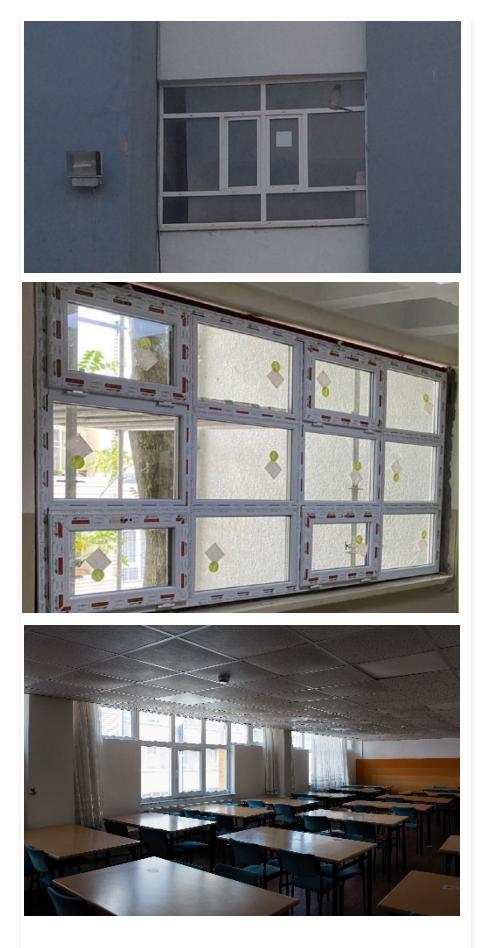
Picture 14. Building windows - Before vs After

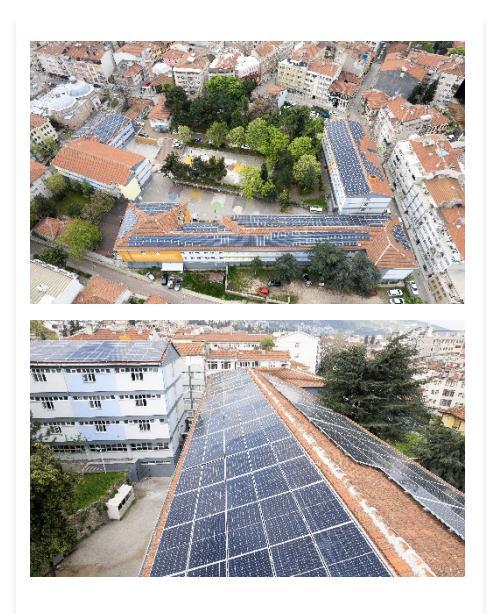
Picture 15. Rooftop solar photovoltaics (PV)

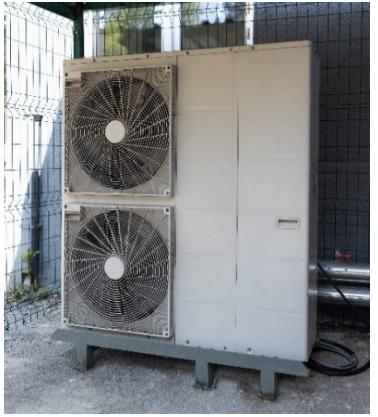
Picture 16. Heat pump application supported by solar PV system

Another revision was replacing solar hot water panel application with heat pump application supported solar bv photovoltaic system. The school rooftop was going to be covered by photovoltaic panels leading to free renewable energy generation that will correspond to the full electricity consumption of the school campus. Since the electricity consumption would be fully sourced from the solar photovoltaic system, it was considered to adopt a heat pump application to both support heating system and domestic hot water system. It would decrease the fossil fuel use in natural gas boilers leading to mitigation of green house gas emissions originating from heating end use and its electricity consumption would be both free and zero emission because its electricity

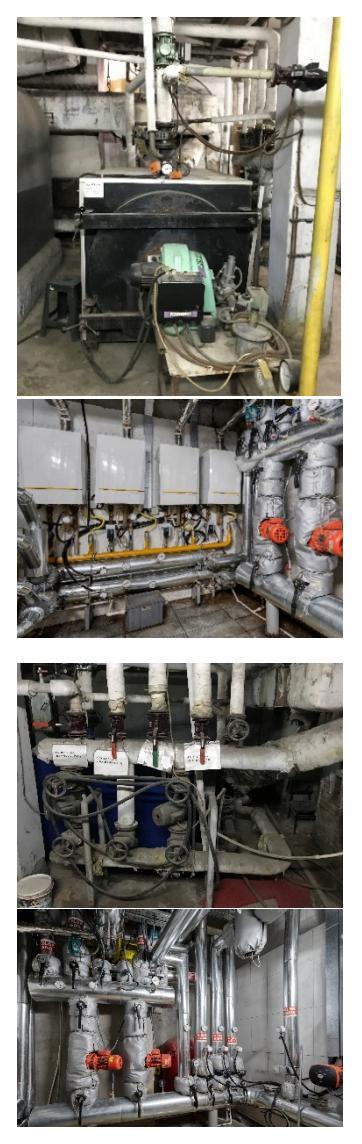
Picture 17. Boiler Room (Boilers, Pumps, Insulation) - Before vs After

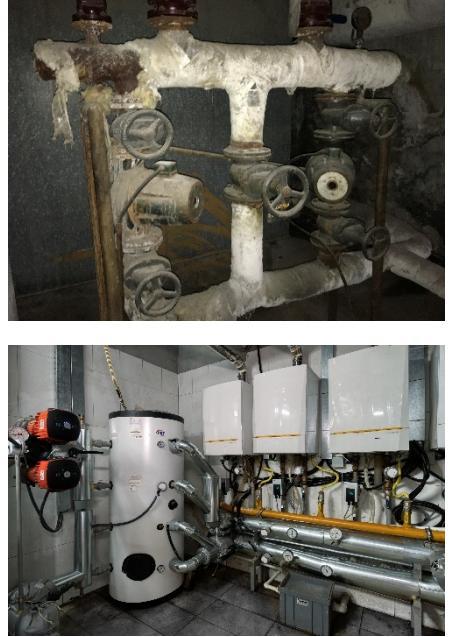
Picture 18. Boiler Room (Boilers, Pumps, Insulation) - Before vs After

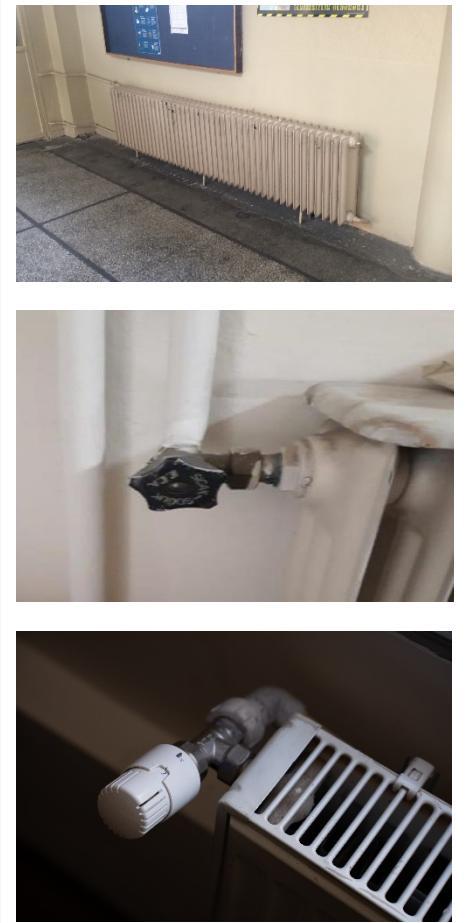
Picture 19. Thermostatic Valves – Before vs After

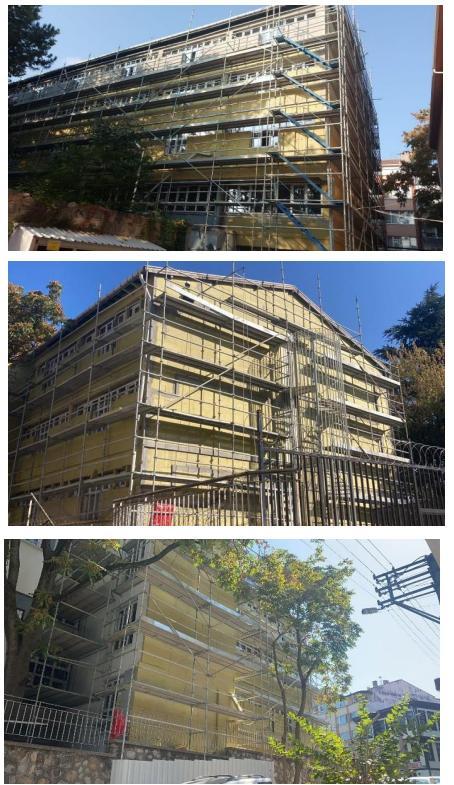
Picture 21. Building insulation application

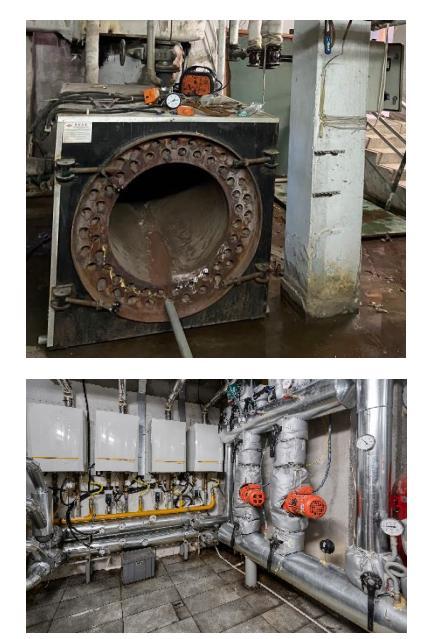
Picture 22. Old boiler disassembly and new boiler room installations

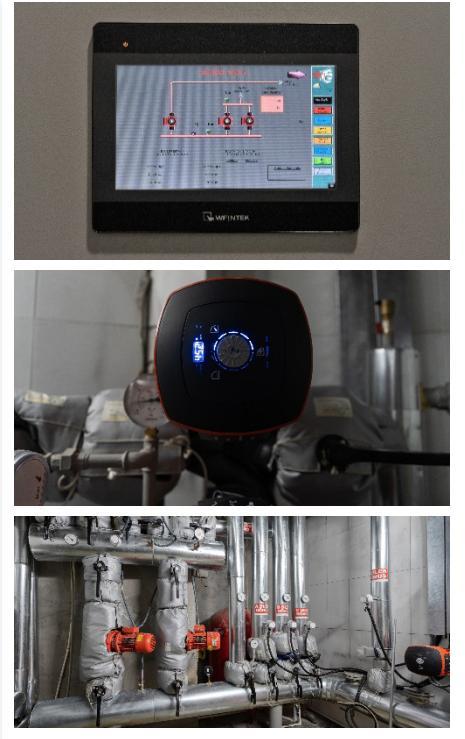
Picture 23. Heating automation system and associated equipment, sensors and valves

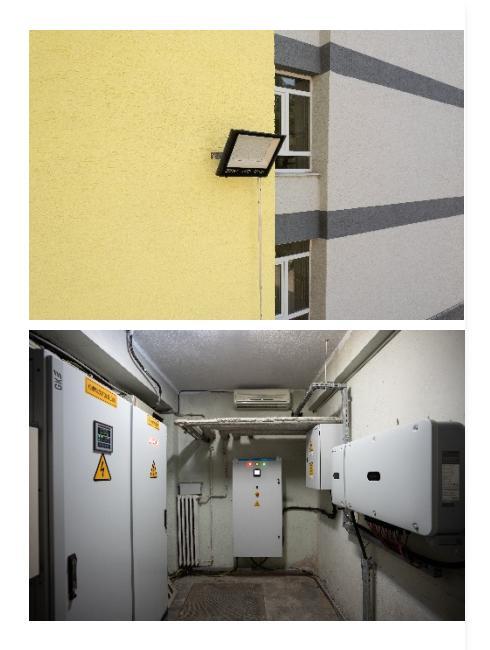
Picture 24. LED exterior lighting bulb and Replacement of compensation, main distribution control panels

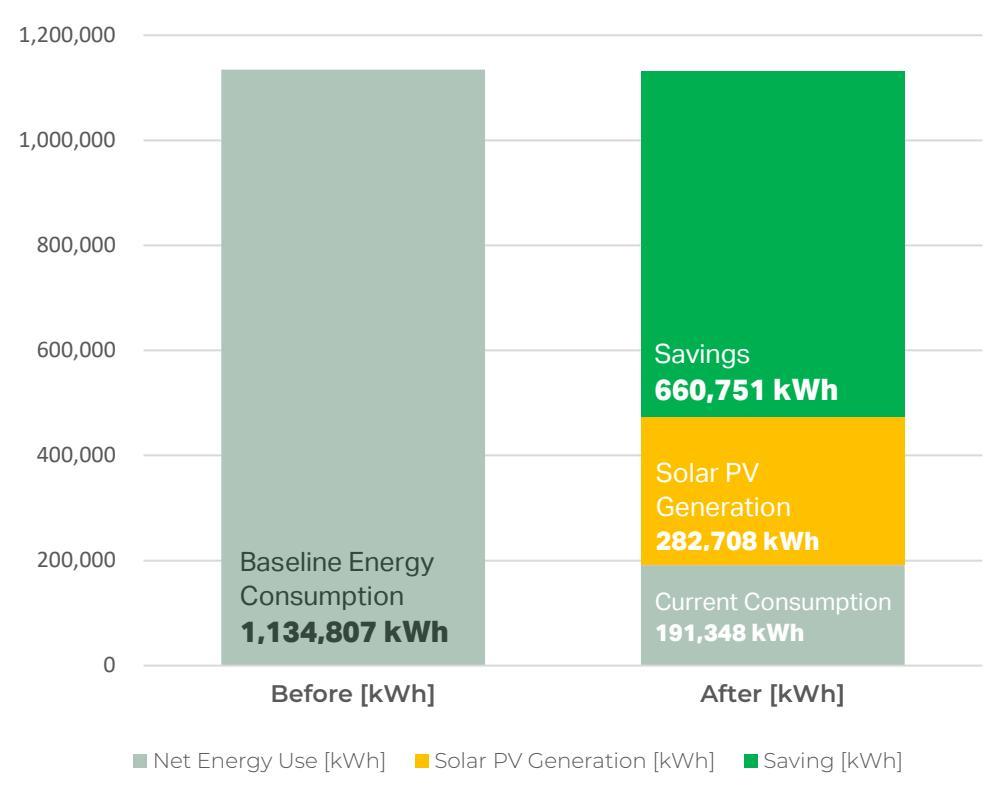
#### Net Energy Use and Total Savings [kWh]

Graph 4. Energy Overview: Baseline Energy Use - Energy Savings - Solar PV Generation = Current Net Energy Use
